Seventeenth Coast Guard District

Alaska Small Passenger Vessel Task Force Report on Improving Safety of Small Passenger Vessel Operations in Alaska

12 April 2000

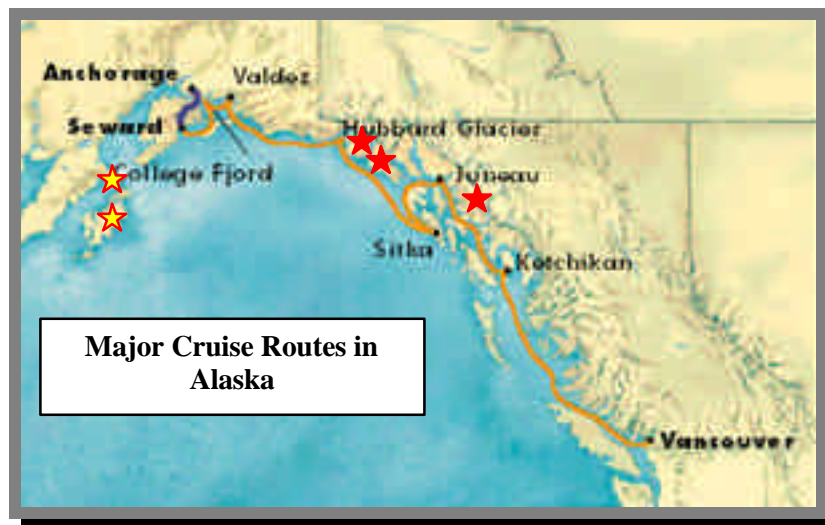
- ★ Approximate location of 1999 inspected vessel accidents
- ★ Approximate location of uninspected vessel sinkings

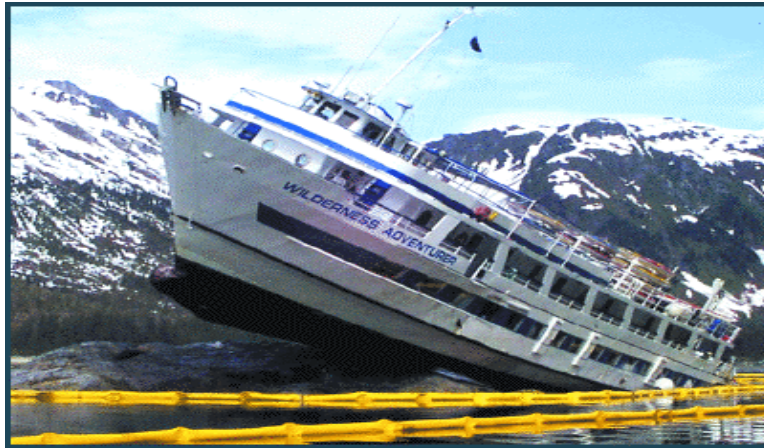
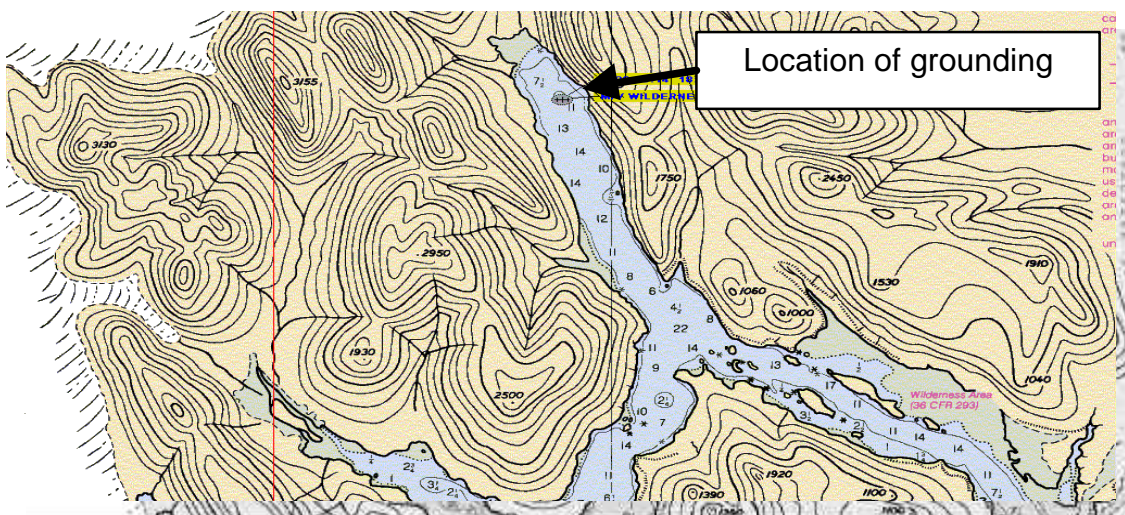
2.1 P/V WILDERNESS ADVENTURER, Dundas Bay, Southeast Alaska. On 12 June 1999, this 156' vessel, grounded on a charted rock in Dundas Bay. 56 passengers and 24 crew were evacuated from the vessel to nearby fishing vessels and a passenger vessel. Approximately 80 gallons of lube oil was released into the water from a crack in the hull by way of the vessel's bow thruster. The vessel grounded at high tide in an area where the tidal range is approximately twenty feet. At low tide the vessel rested precariously on a rock with the bow high and its stern in the water, at a forty-degree list. The response included Coast Guard representatives from MSO Juneau and the Pacific Strike Team, National Park Service, State of Alaska Department of Environmental Conservation, and South East Alaska Pollution Response Organization's (SEAPRO) personnel and seven of their vessels. The vessel was safely re-floated a few days later on a favorable high tide and towed to a repair facility.

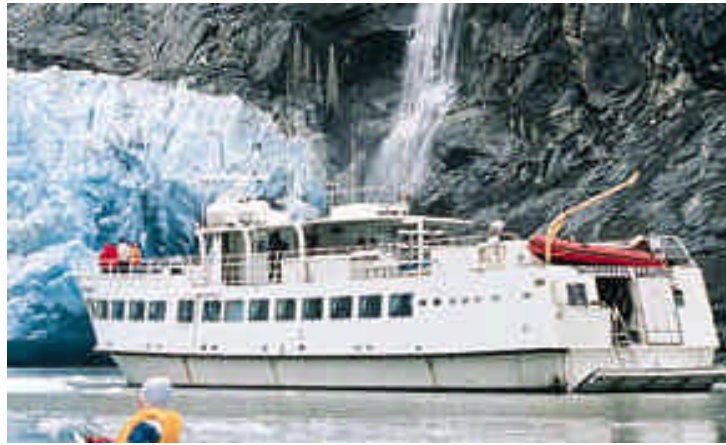
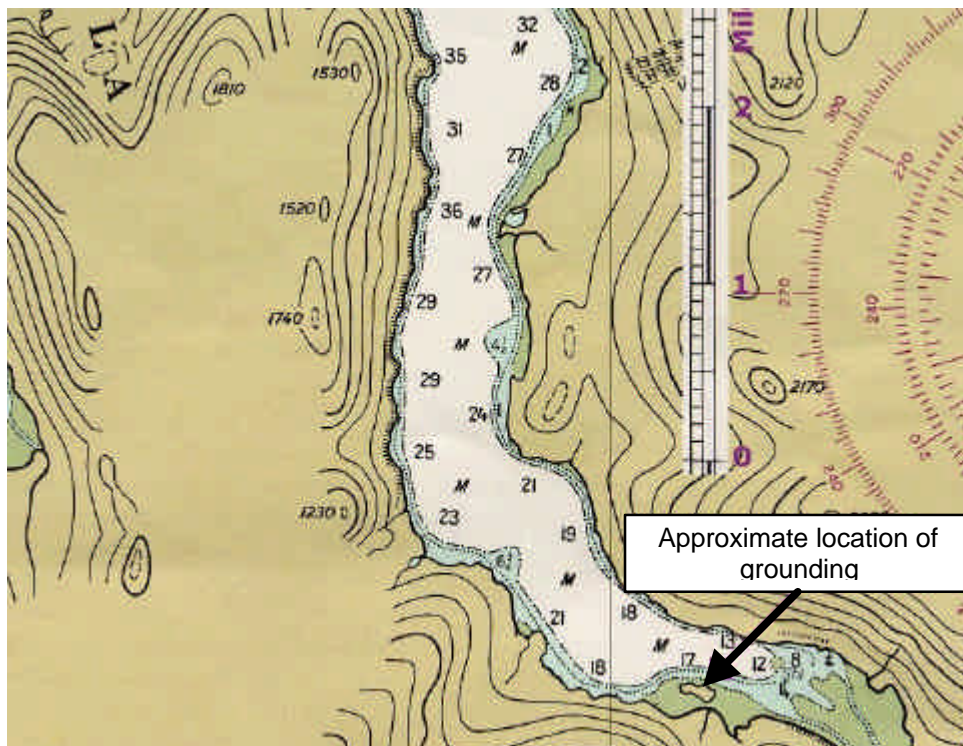
2.2 P/V WILDERNESS EXPLORER in Idaho Inlet, Southeast Alaska. On 19 July 1999, this 110' vessel made a routine entry into the inlet to anchor for the evening. Once in the inlet, the operator of the WILDERNESS EXPLORER observed another vessel in the vessel's normal anchorage area and proceeded to locate a new anchorage within the inlet. The vessel grounded in soft mud on a charted shoal area with 58 passengers on board. The crew and passengers remained on the vessel until it floated on the next high tide without incident.

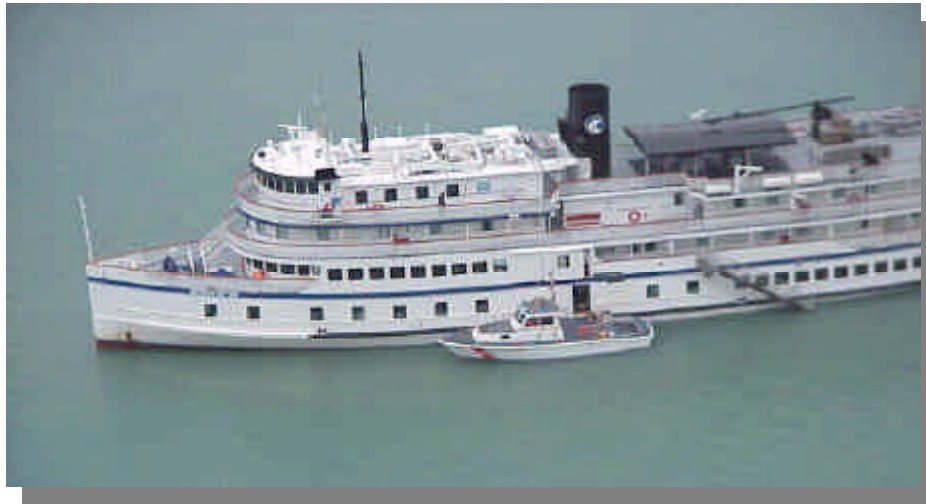
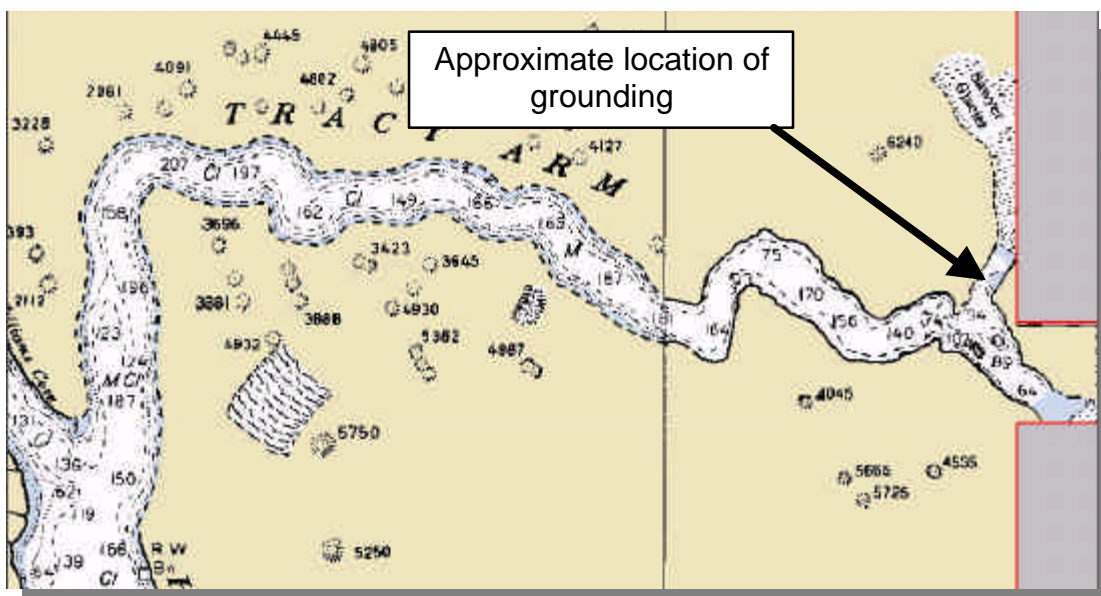
2.3 P/V SPIRIT OF 98 in Tracy Arm, Southeast Alaska. On 27 July 1999, this 150' vessel was following another small passenger vessel into the North Sawyer Glacier Arm in the vicinity of a charted shoal area, when the hull scraped along the bottom and sustained damage to the keel cooler and its attachment to the hull. The damage resulted in uncontrolled flooding requiring the evacuation of 126 passengers onto an assisting vessel. The SPIRIT OF 98 then proceeded four miles down the fjord to intentionally ground on the nearest safe shoal area. During the transit, both engines failed due to thirteen feet of water in the engine room, one just prior to the vessel reaching the grounding site. There was no environmental damage caused by this accident. The Coast Guard air lifted de-watering pumps and dispatched three vessels to assist in dewatering the vessel. Divers made temporary repairs and the vessel was refloated and towed to a repair facility.
